June 24, 2024

The WCID board contracted the dam improvements proposed by the engineering firm back in 2019. The one area to build up is around the low flow pipe. The area around the low flow pipe has the largest slope and is the narrow part on the top of the dam. The back side of the dam around the low flow pipe is shown in figure 1 through 4. The front side of the dam around the low flow pipe is shown in figure 6. The WCID board received quotes from SRB in Colmesneil, TX and Kirkpatrick in Woodville, TX. The board evaluated both bids and the contract was awarded to SRB. SRB proposed building a rock wall above the low flow pipe and then adding dirt above it. The rock wall will hold the dirt better than just adding dirt and packing it down. SRB has also proposed building up the low area close to the spillway. SRB said that the low area was due to erosion and needed to be repaired. The board decided to go ahead with building up the low area as well. The low area is shown in figure 5. Just prior to getting the quotes for the work on the dam, pigs came out and damaged a large area on the front of the dam. The board decided to repair the hog damage shown in figure 4. The board also dec

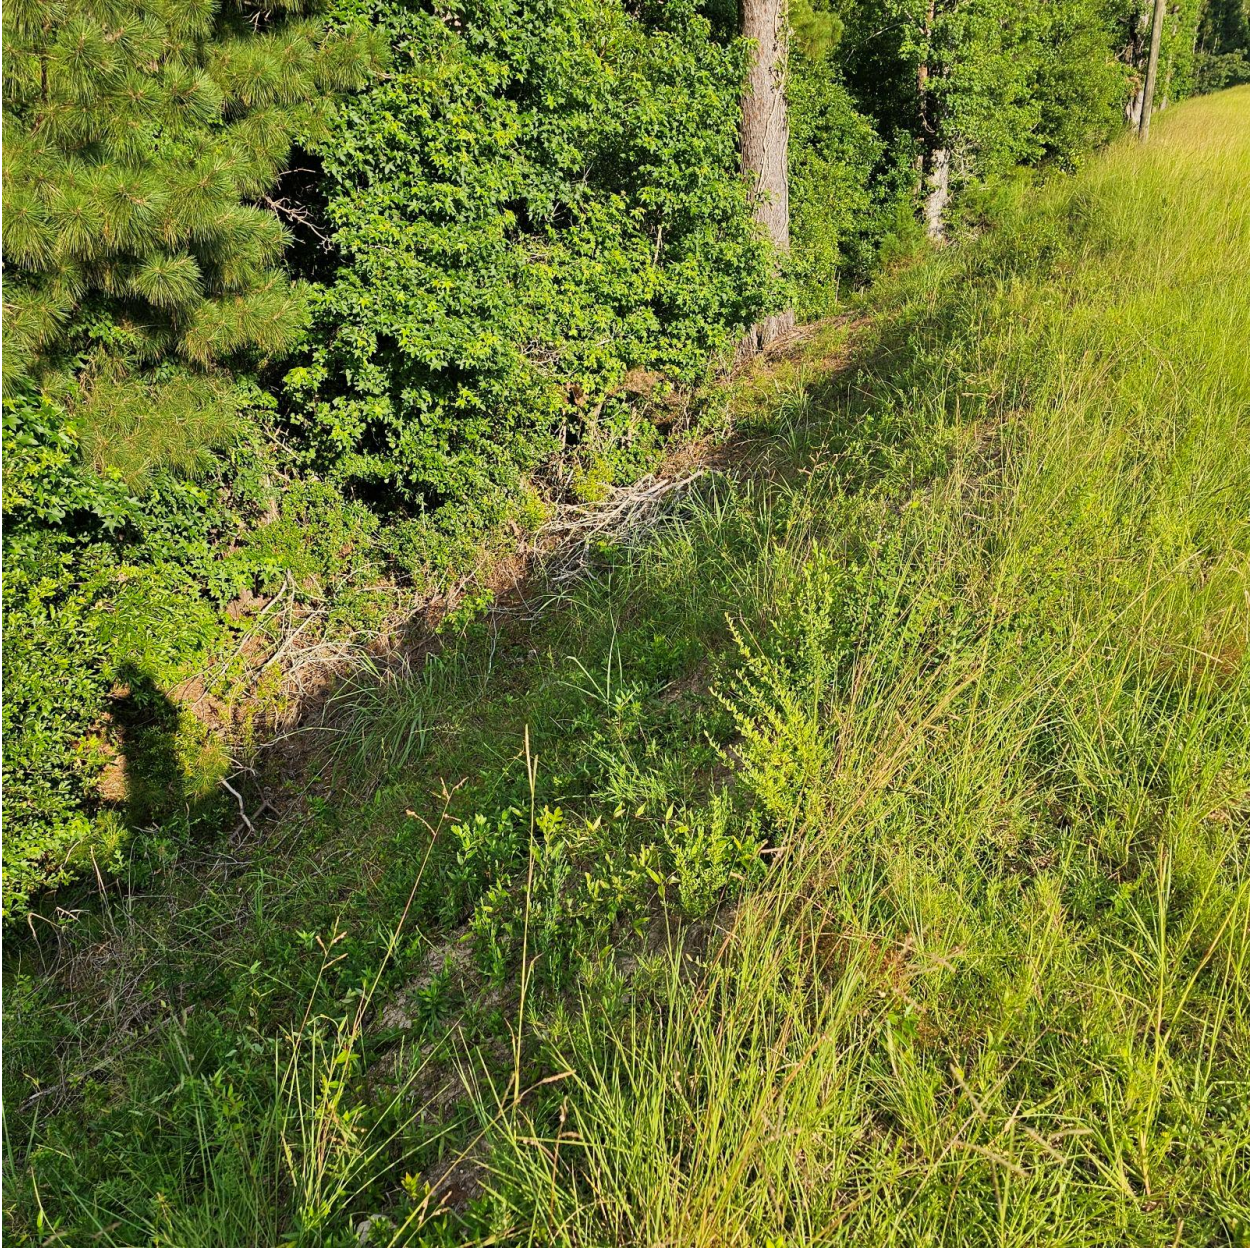
***Figure 1 - Back of the dam around low flow pipe facing South. Before work was done***

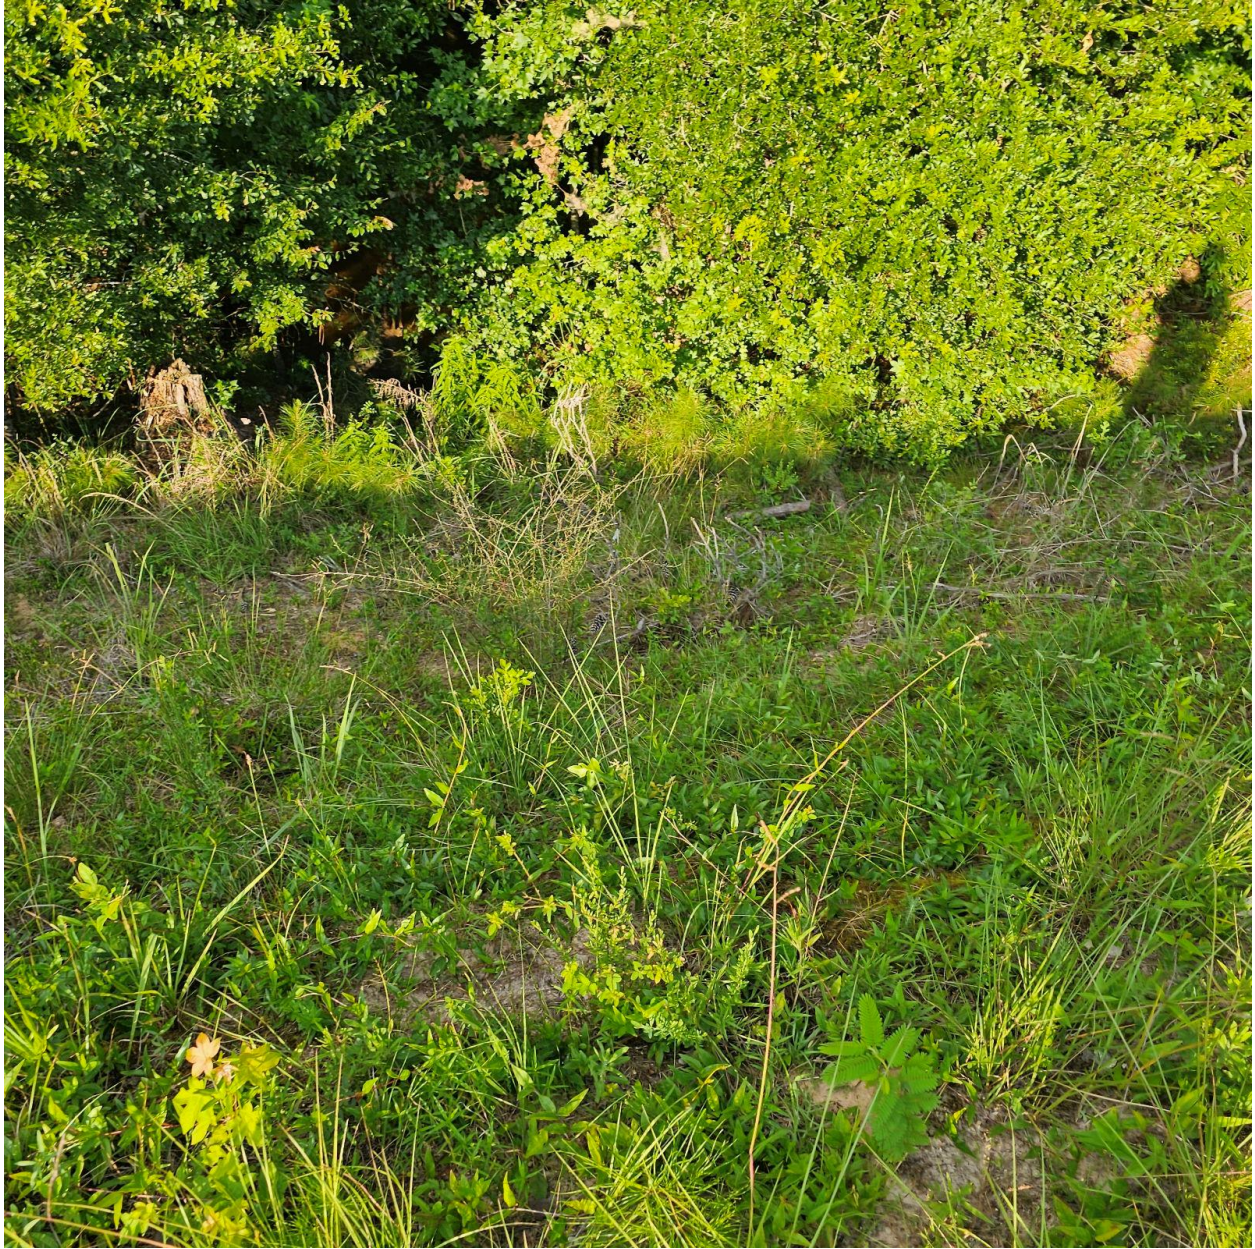
***Figure 2 - Back of the dam around low flow pipe. Before work was done***

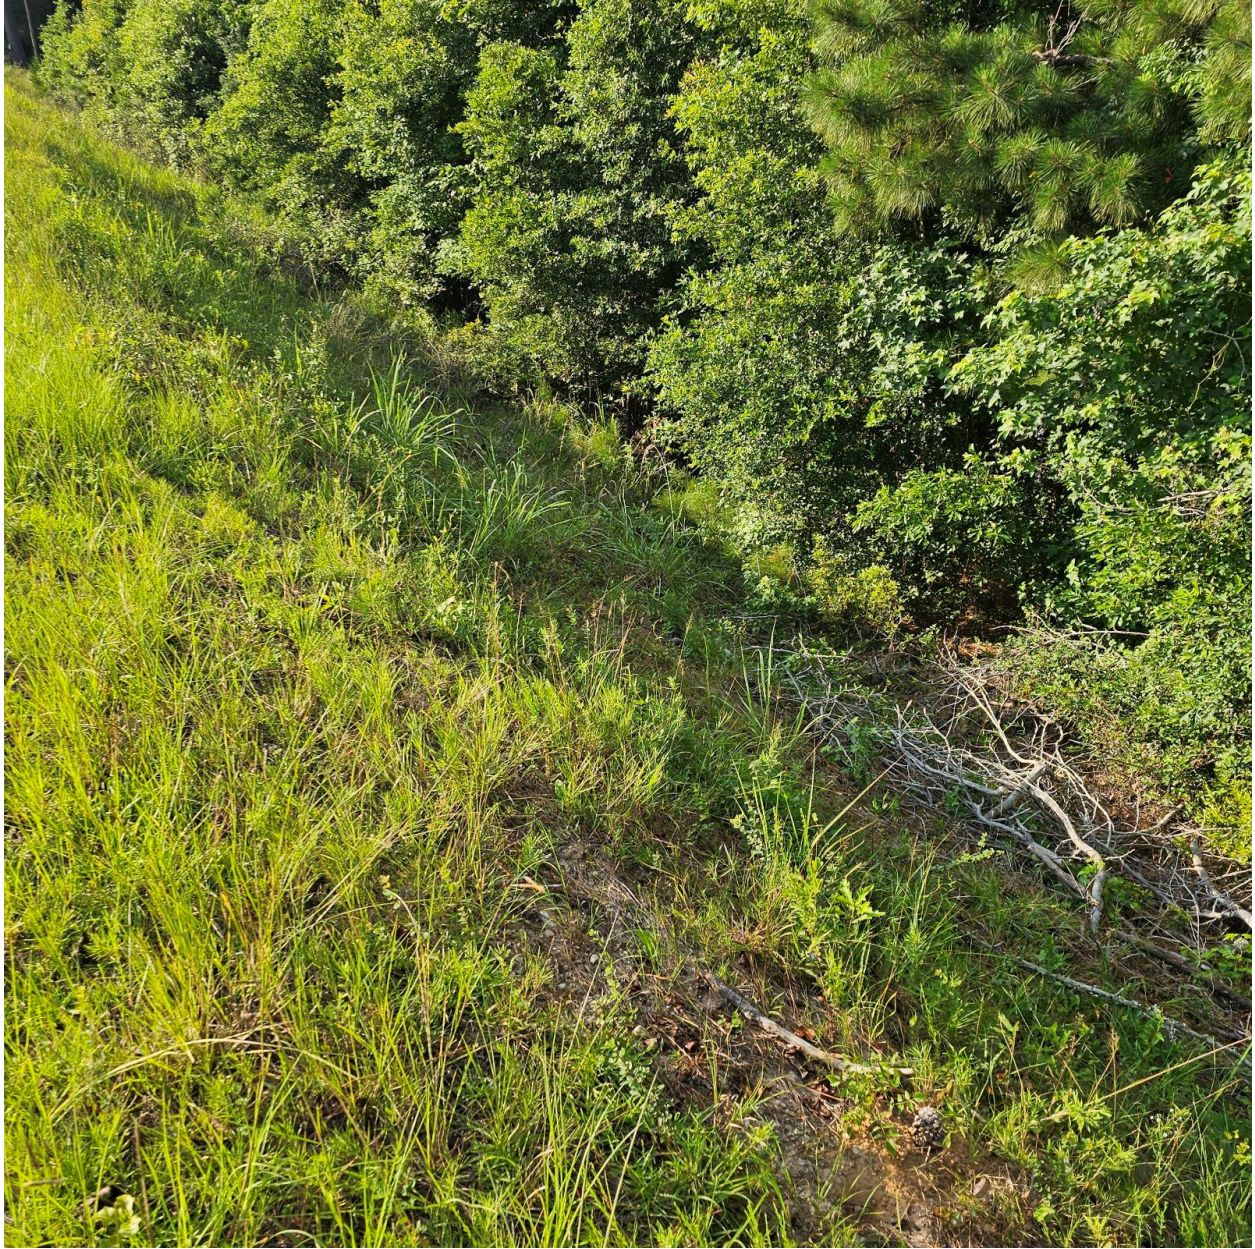
***Figure 3 - Back of the dam around low flow pipe facing North. Before work was done***

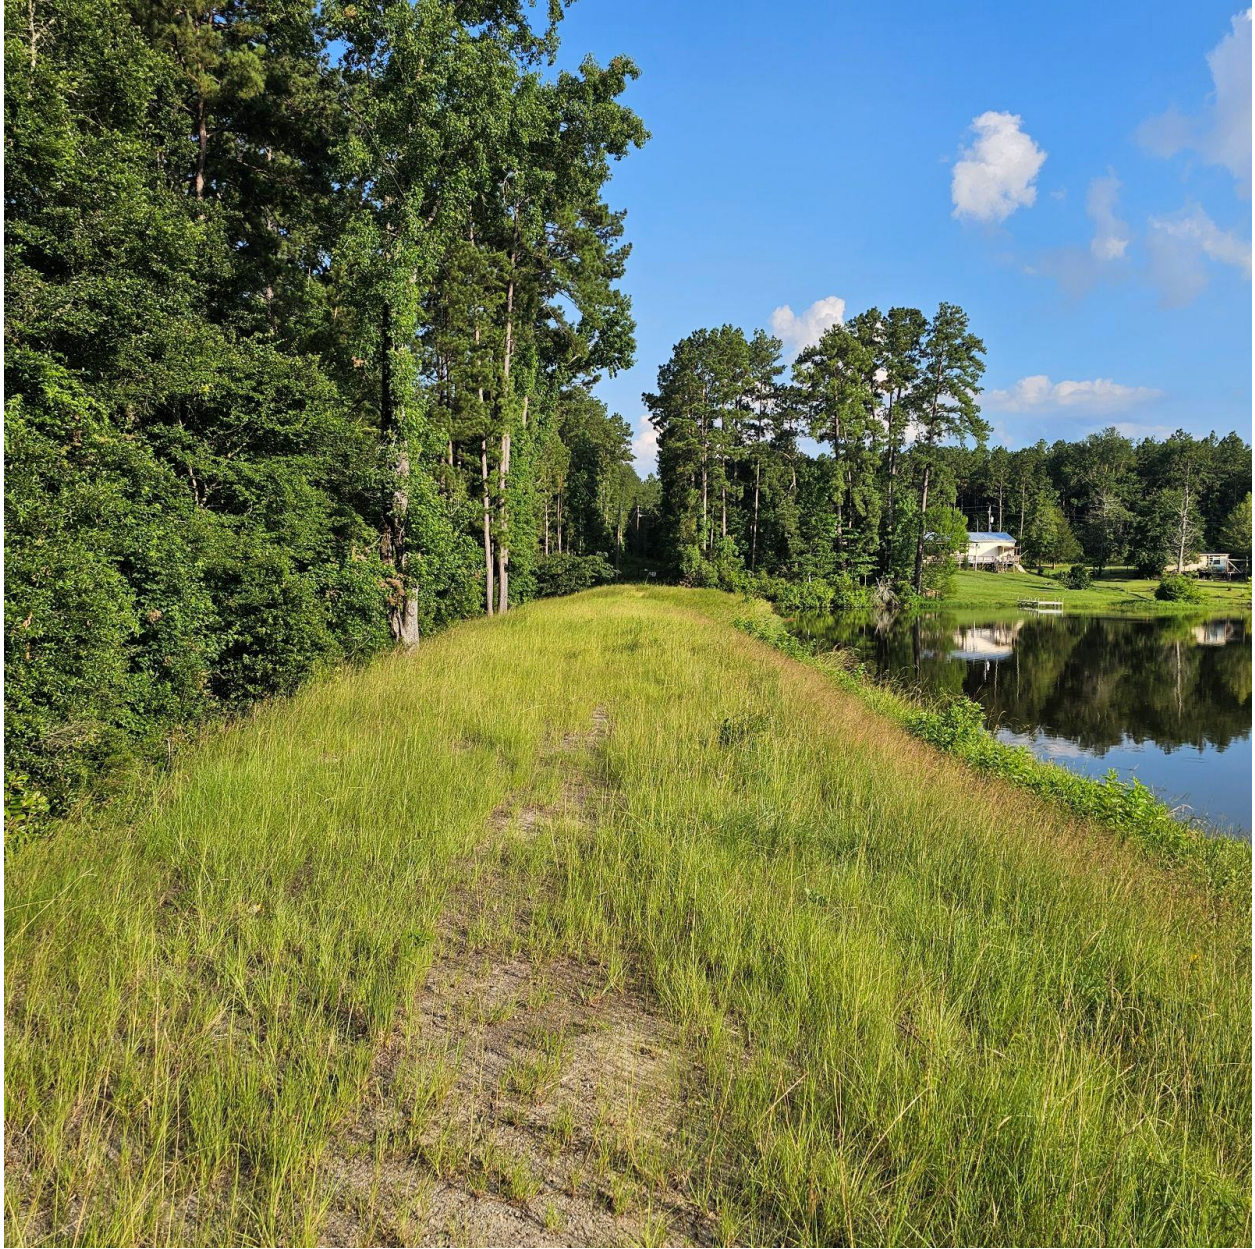
***Figure 4 - Top of the dam around low flow pipe facing South. Before work was done***

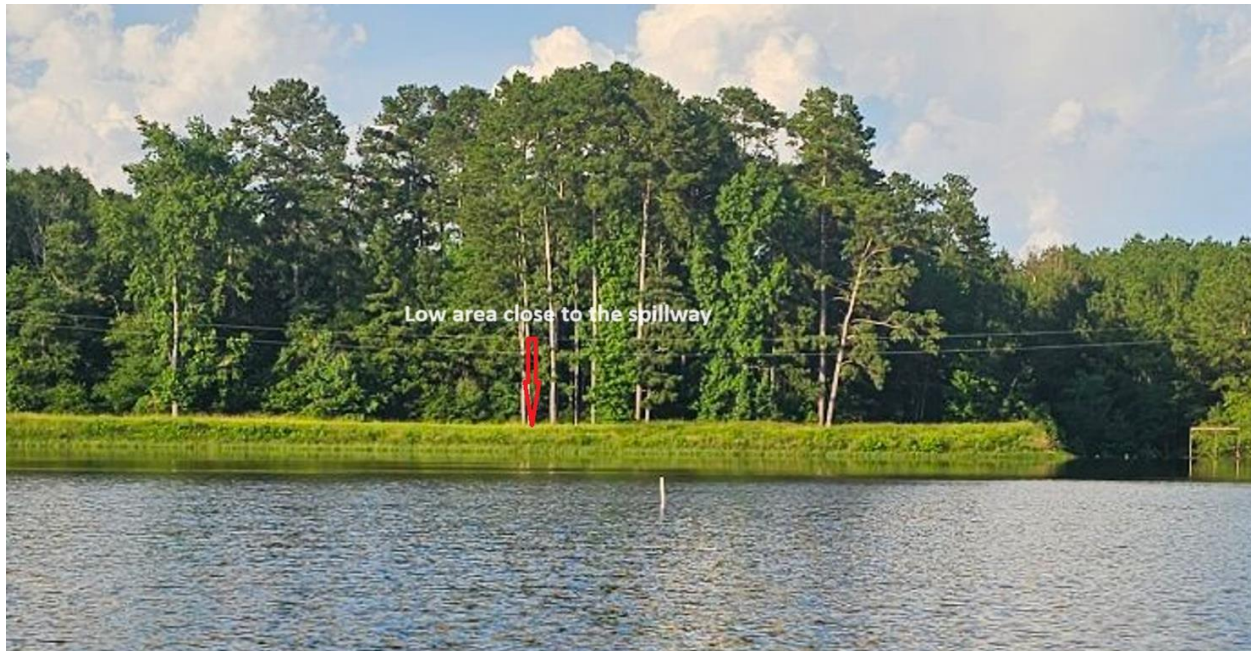
***Figure 5 - Low area close to the spillway. Before work was done***

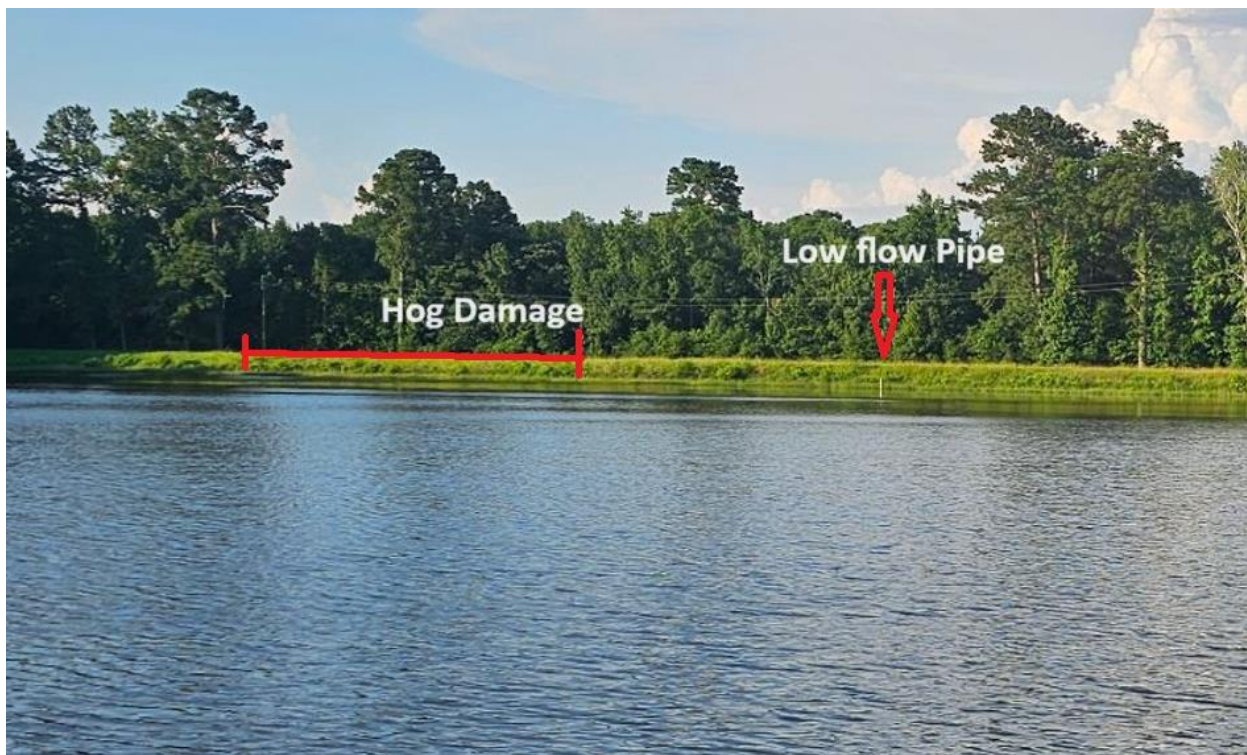
***Figure 6 - Area around low flow pipe and hog damage. Before work was done***

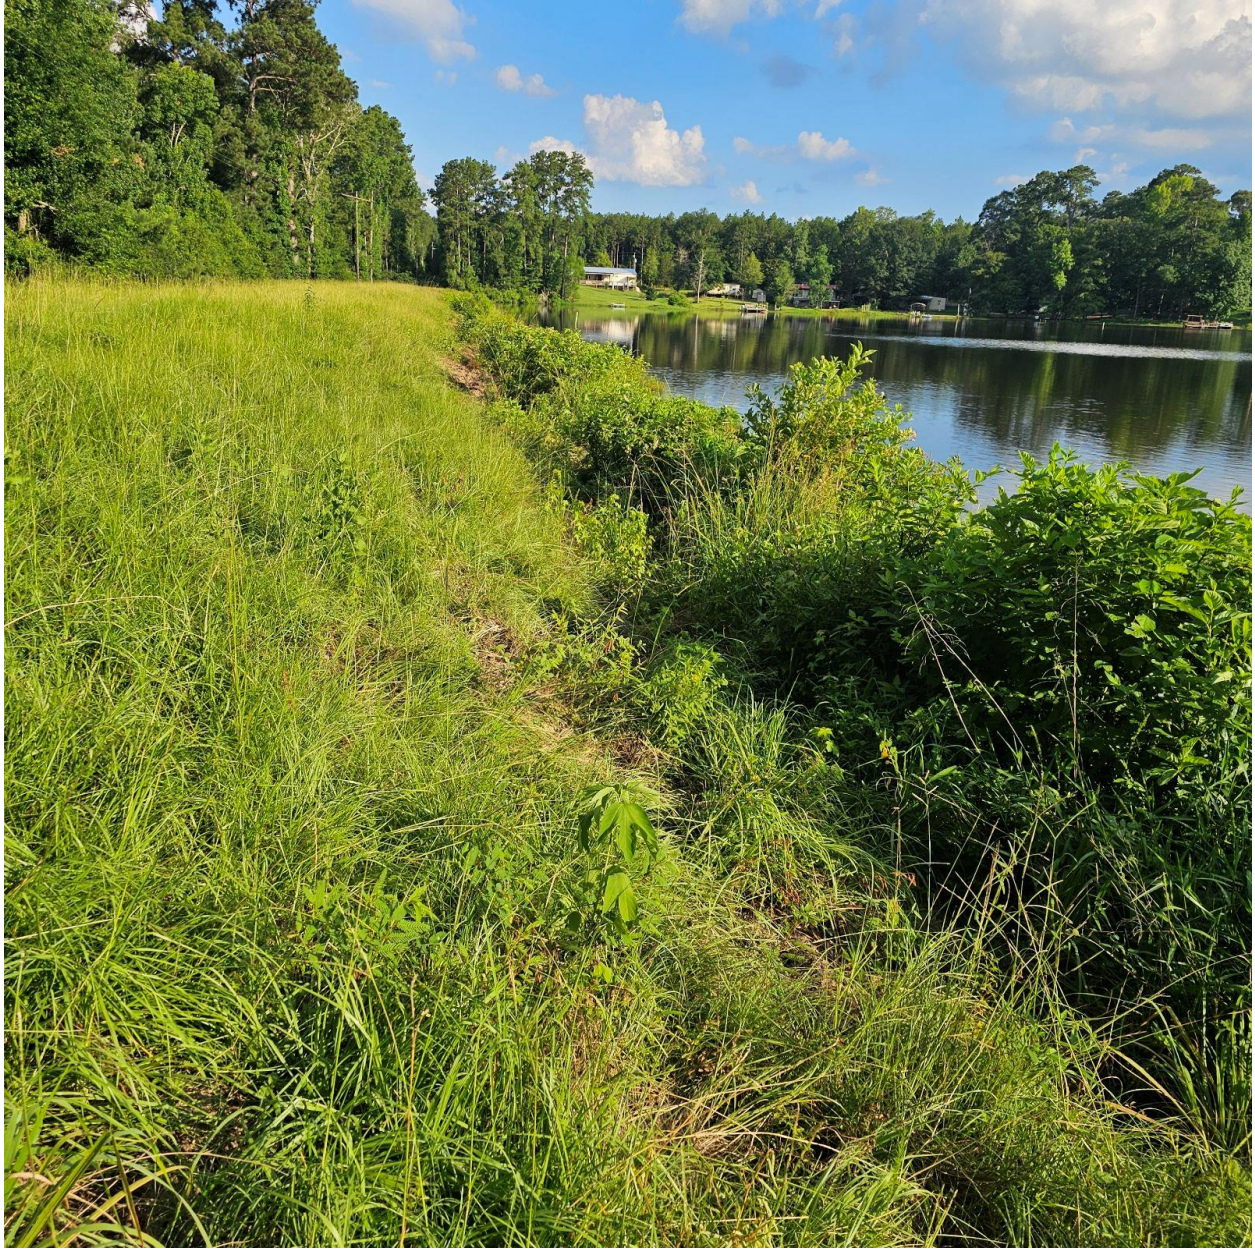
***Figure 7 - Hog damage facing South. Before work was done***

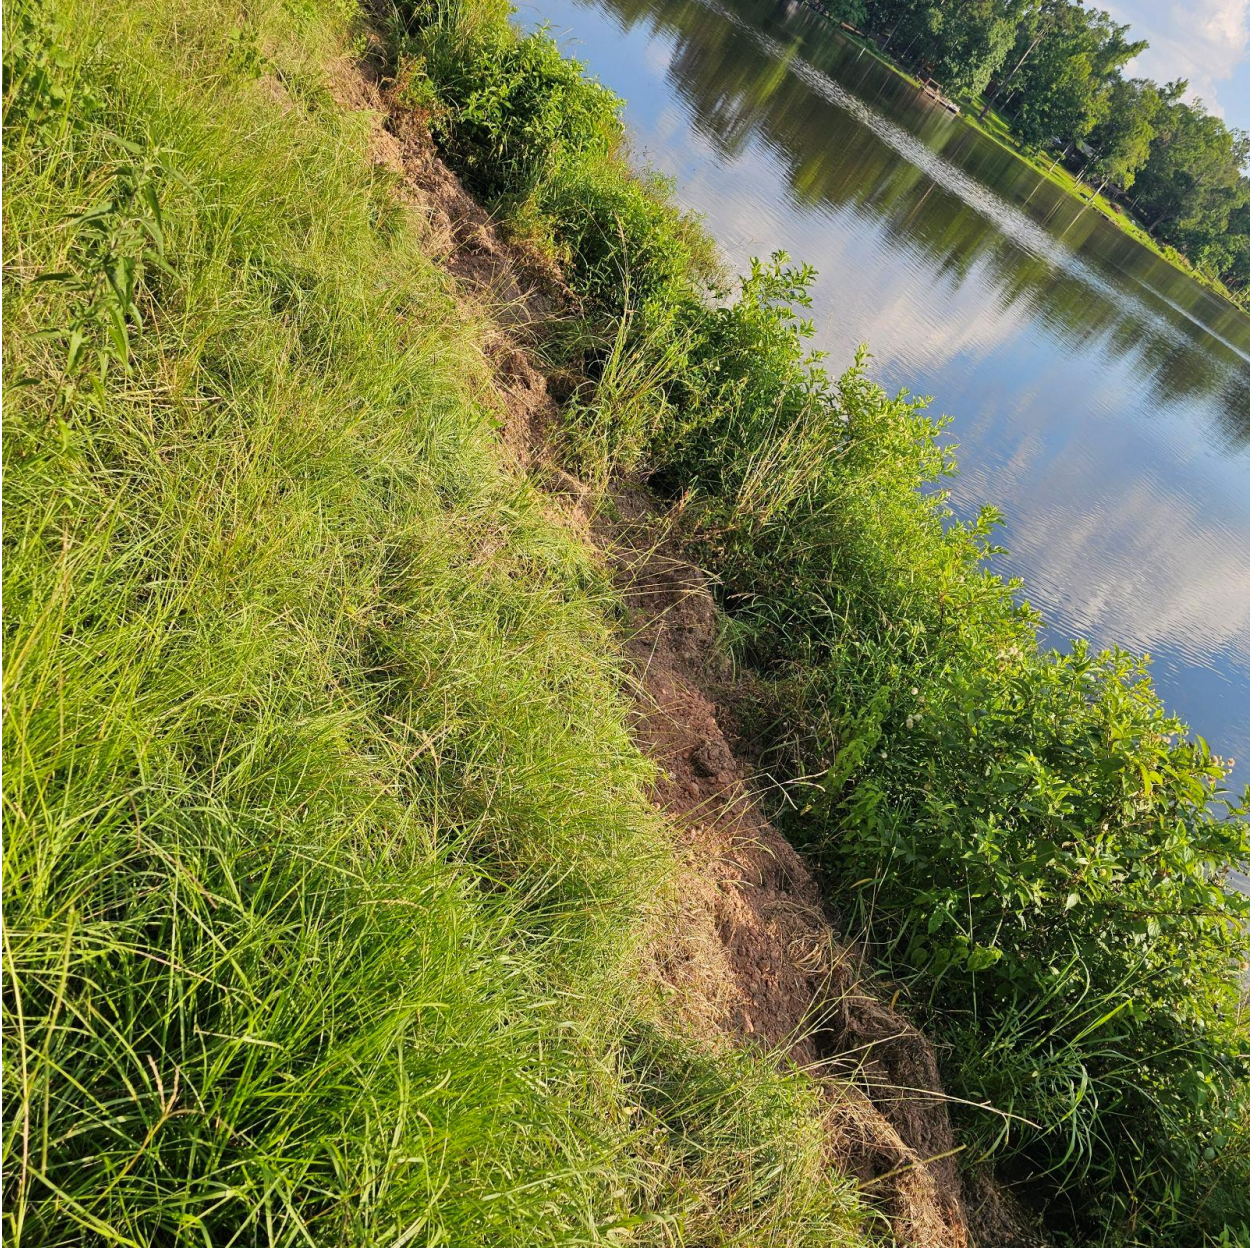
***Figure 8 - Hog damage facing South. Before work was done***

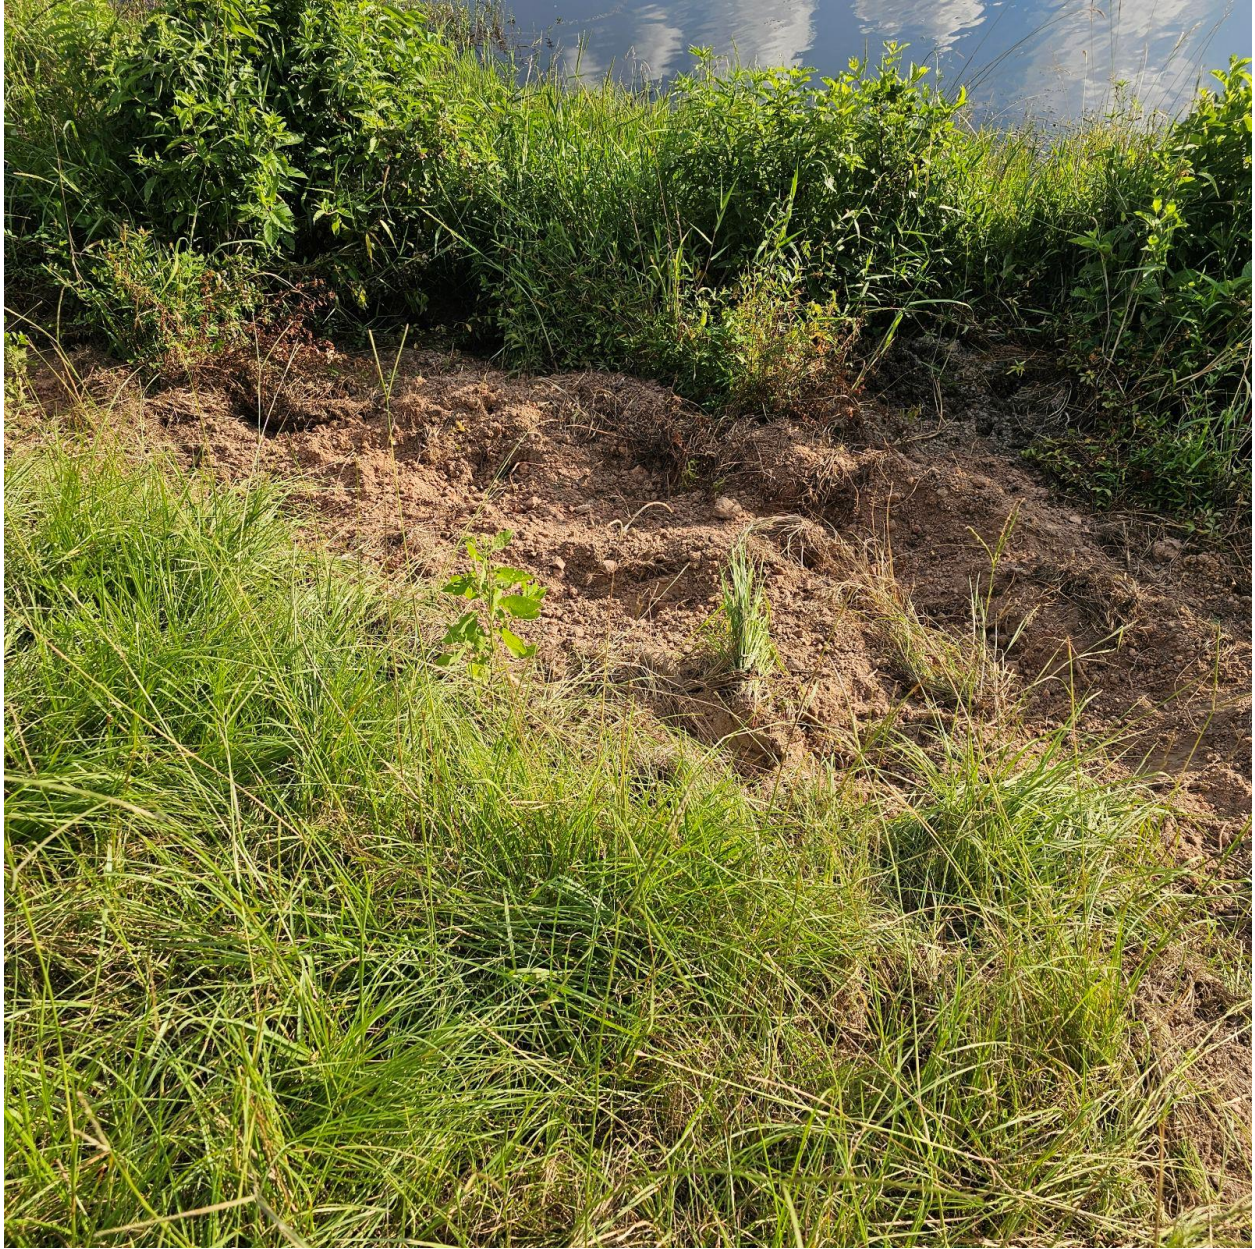
***Figure 9 - Hog damage. Before work was done***

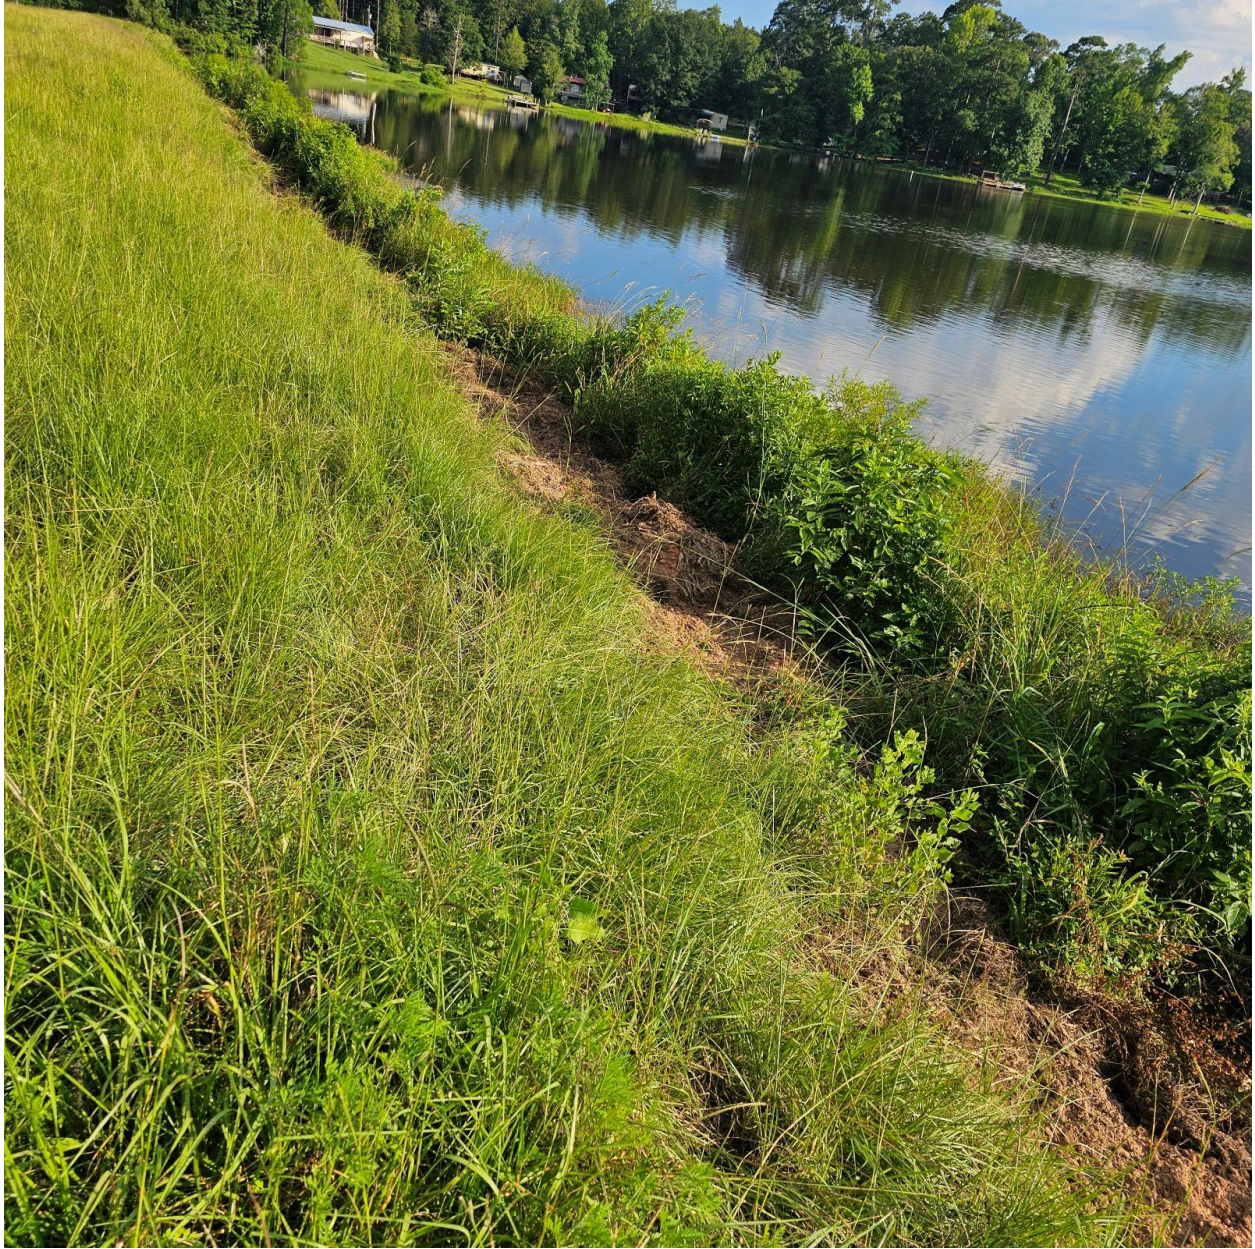
***Figure 10 - Hog damage. Before work was done***

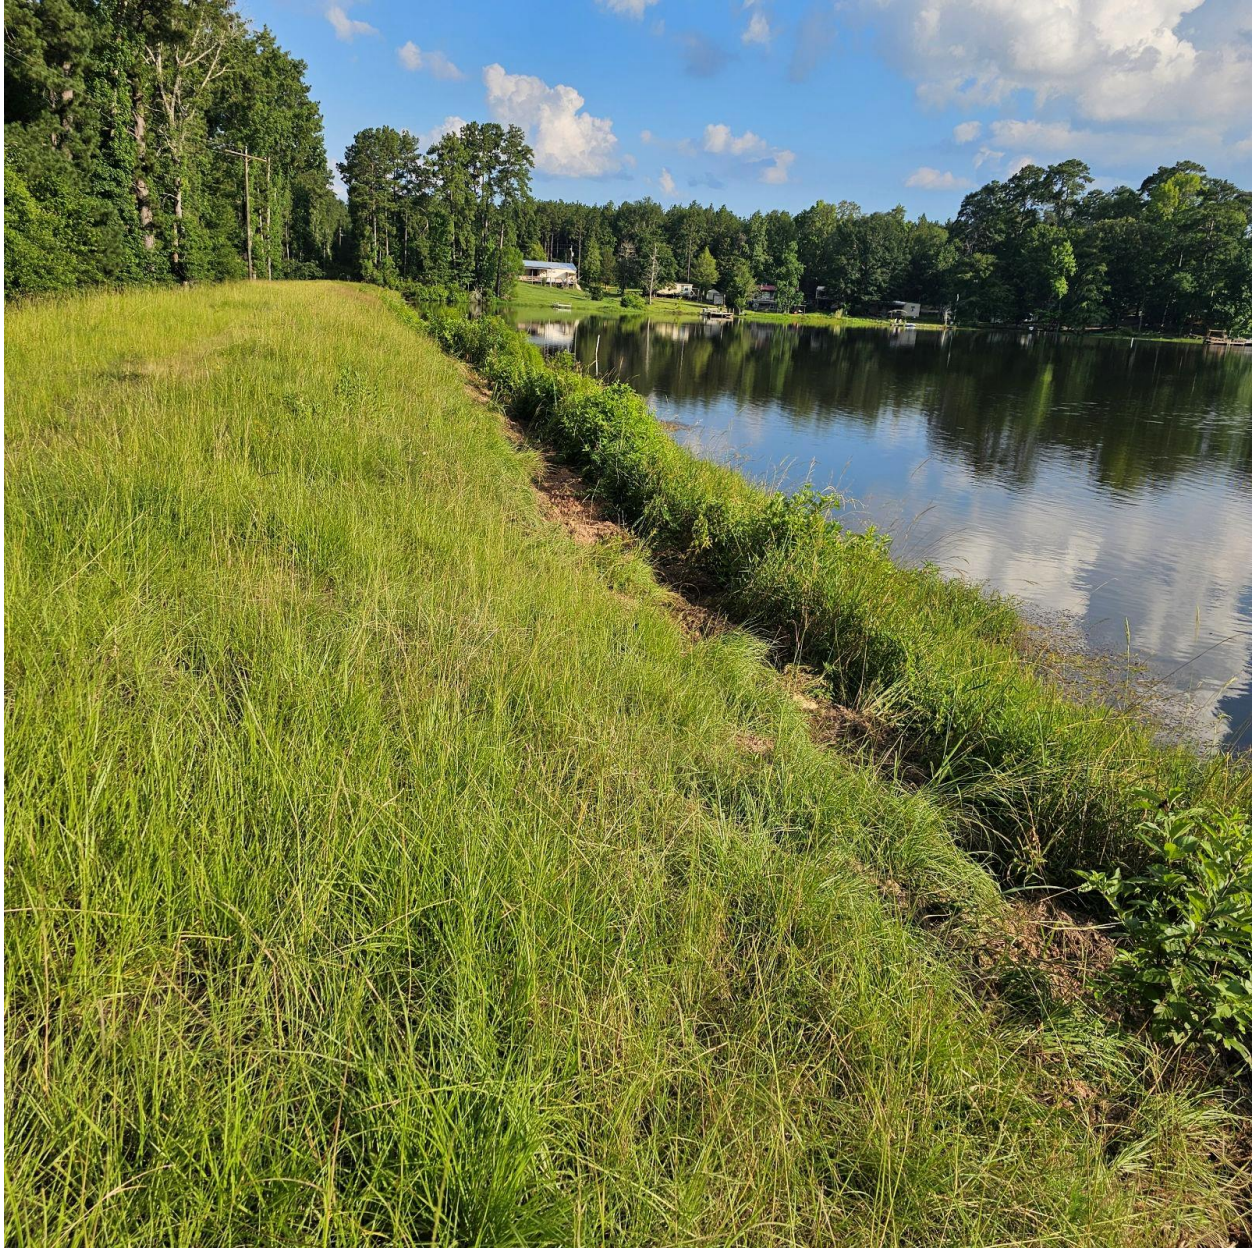
***Figure 11 - Hog damage. Before work was done***

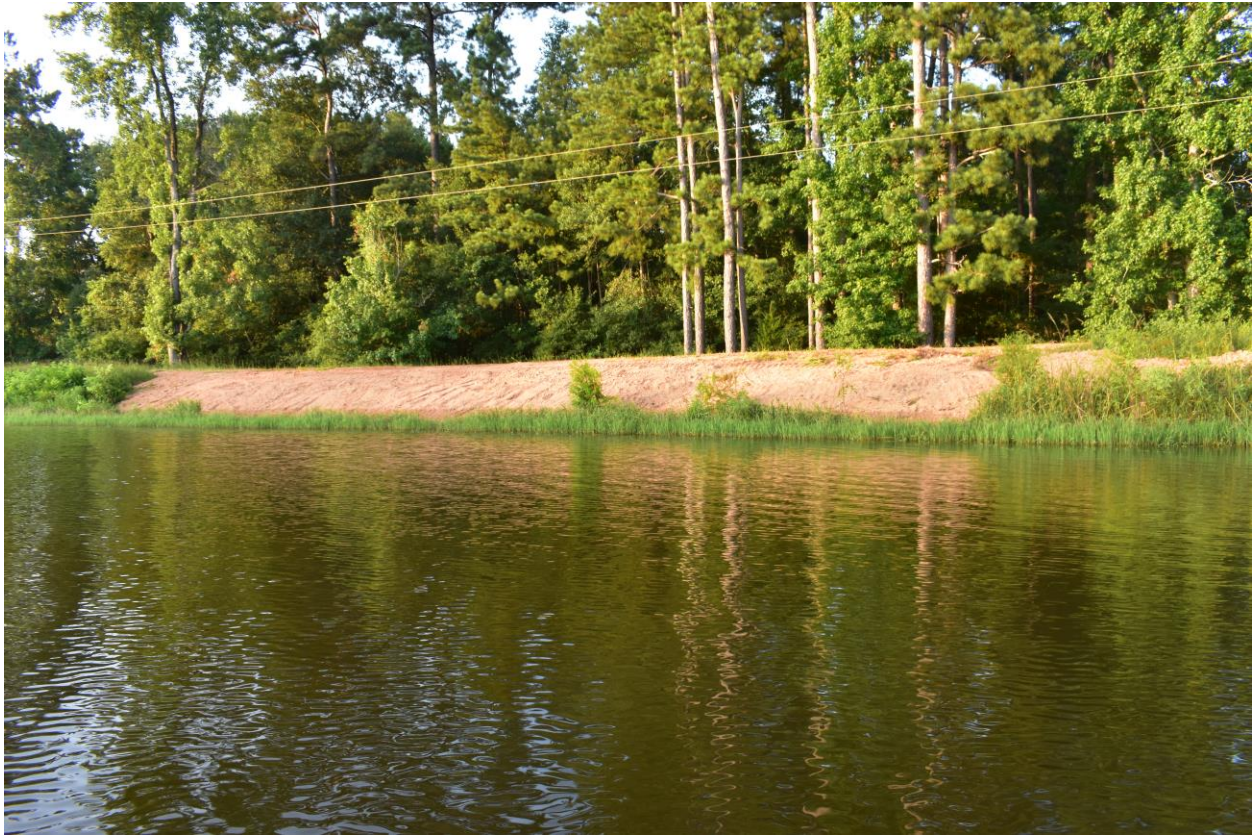
***Figure 12 - Low area close to the spillway Before erosion control mat***

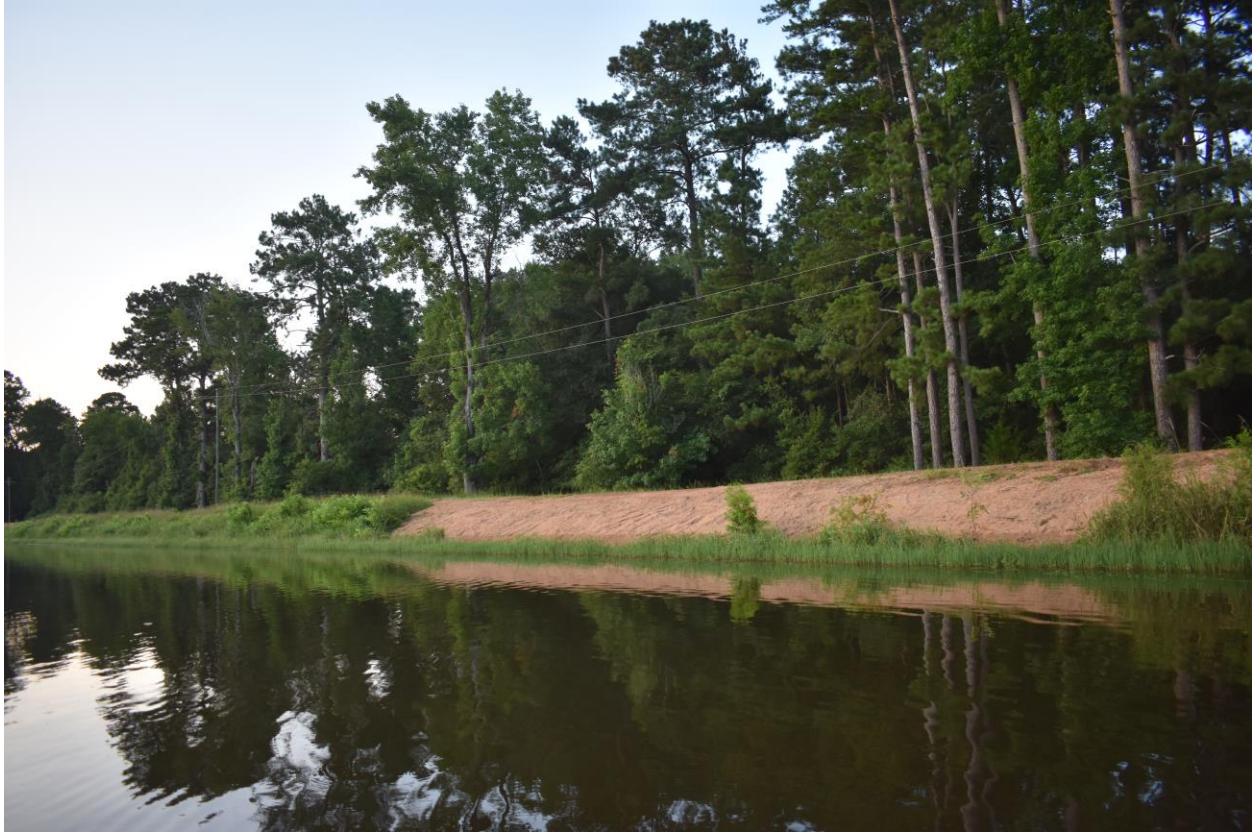
***Figure 13 - Low area close to the spillway Before erosion control mat***

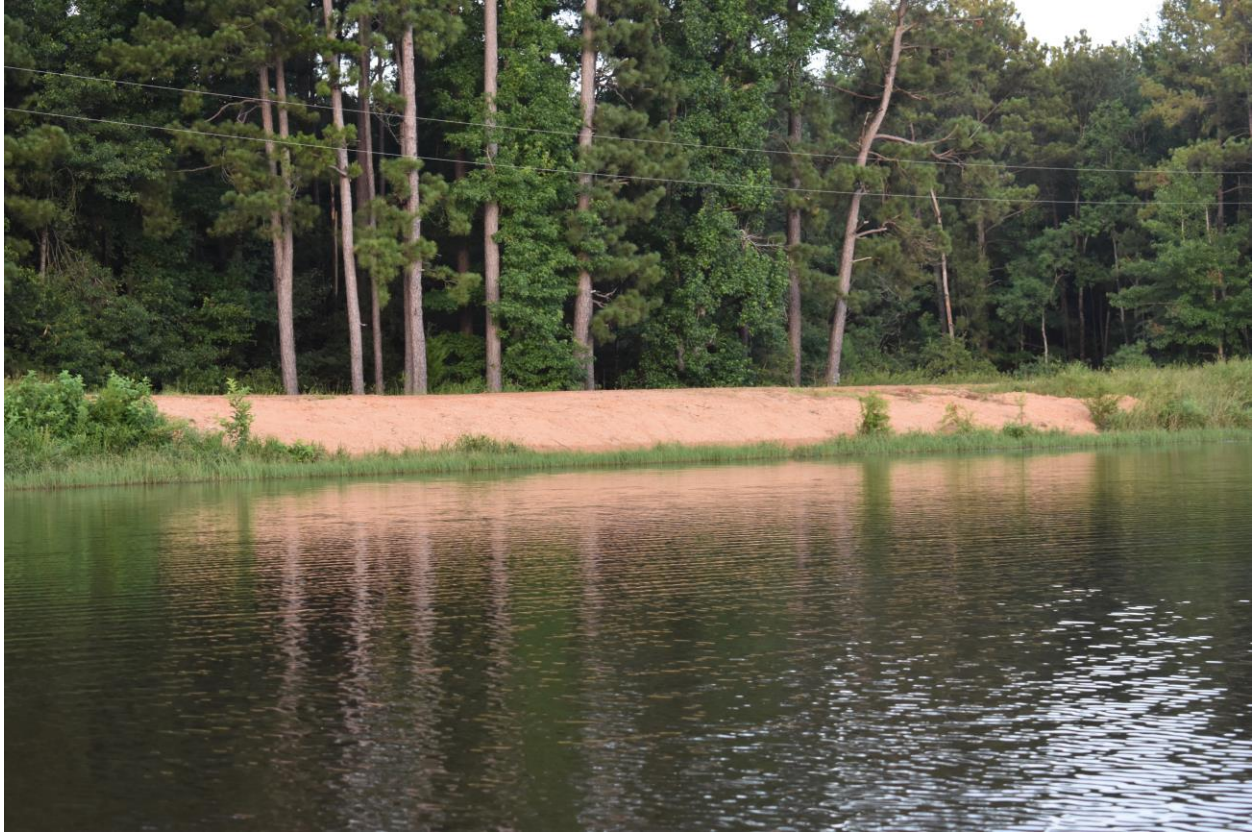
***Figure 14 - Low area close to the spillway Before erosion control mat***

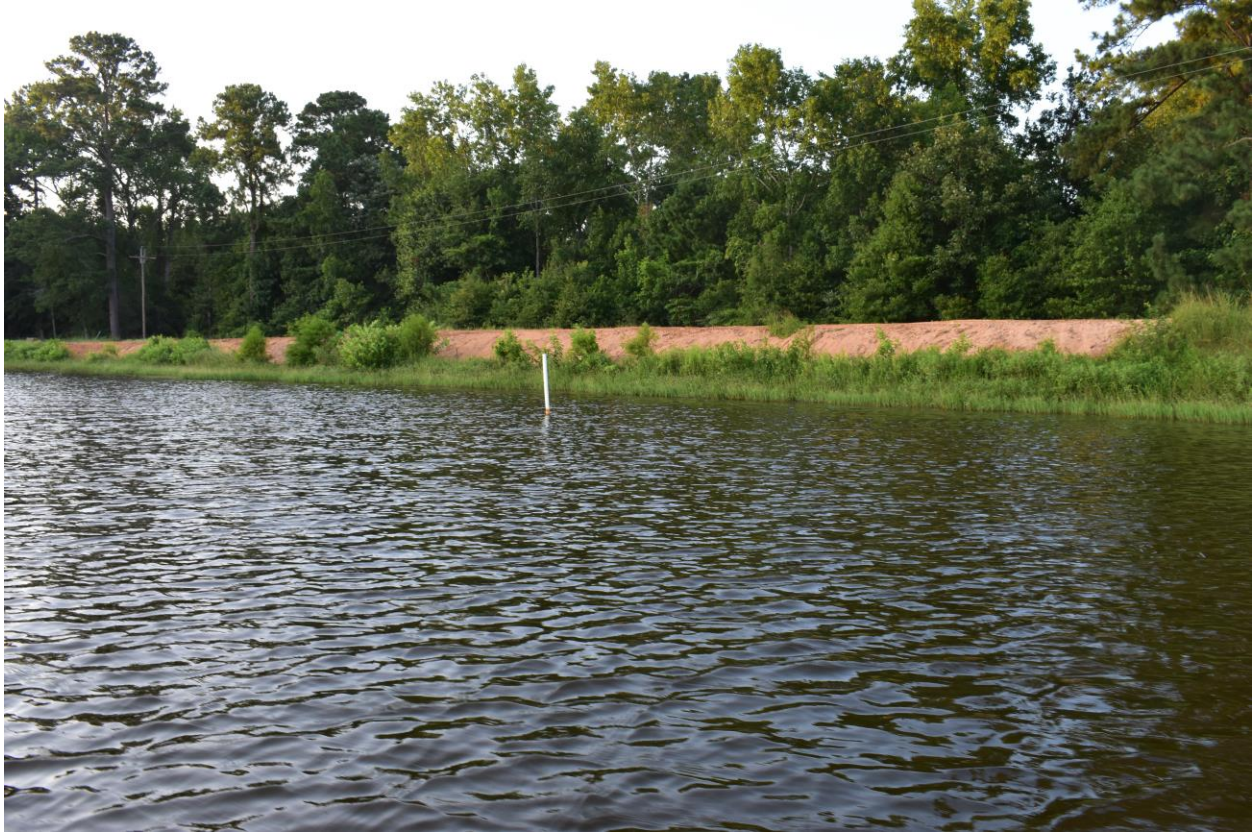
***Figure 15 - Front of the low flow pipe and hog damage. Before erosion control mat***

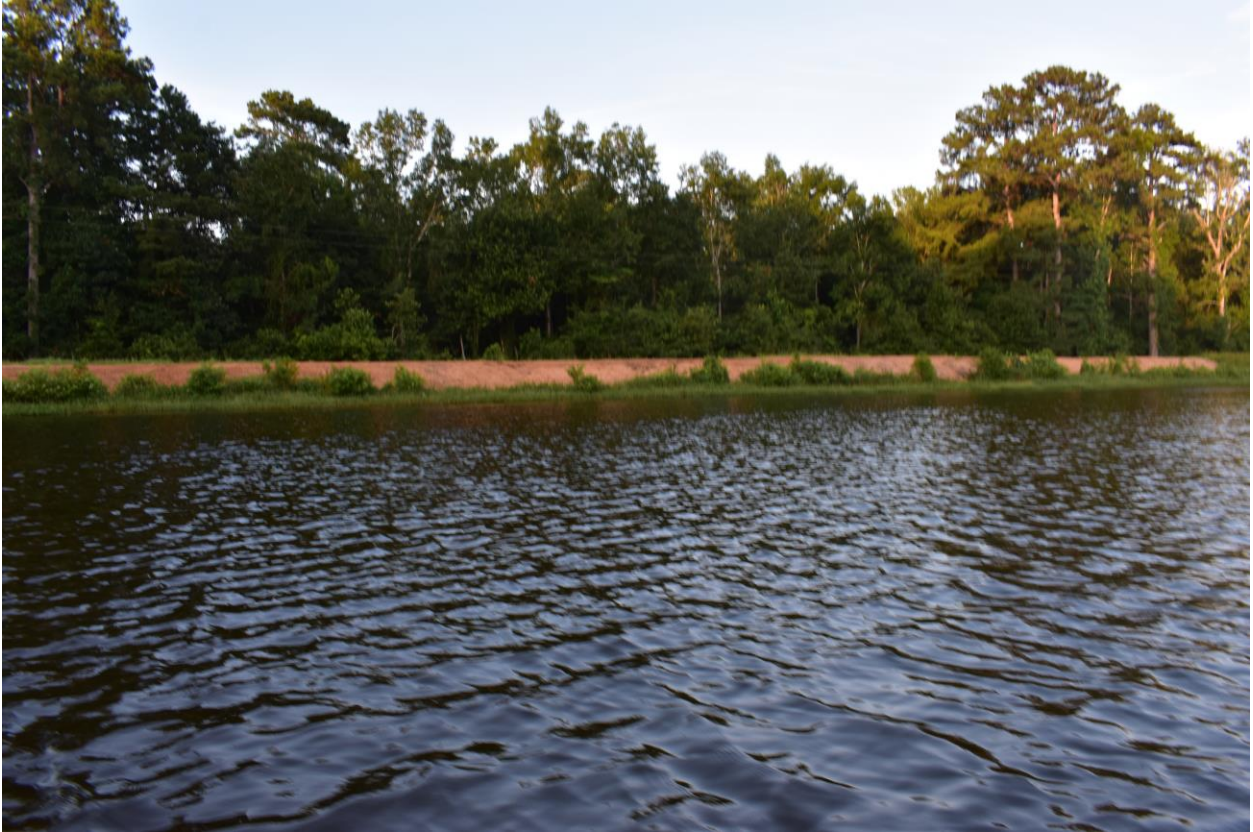
***Figure 16 - Front of the low flow pipe and hog damage. Before erosion control mat***

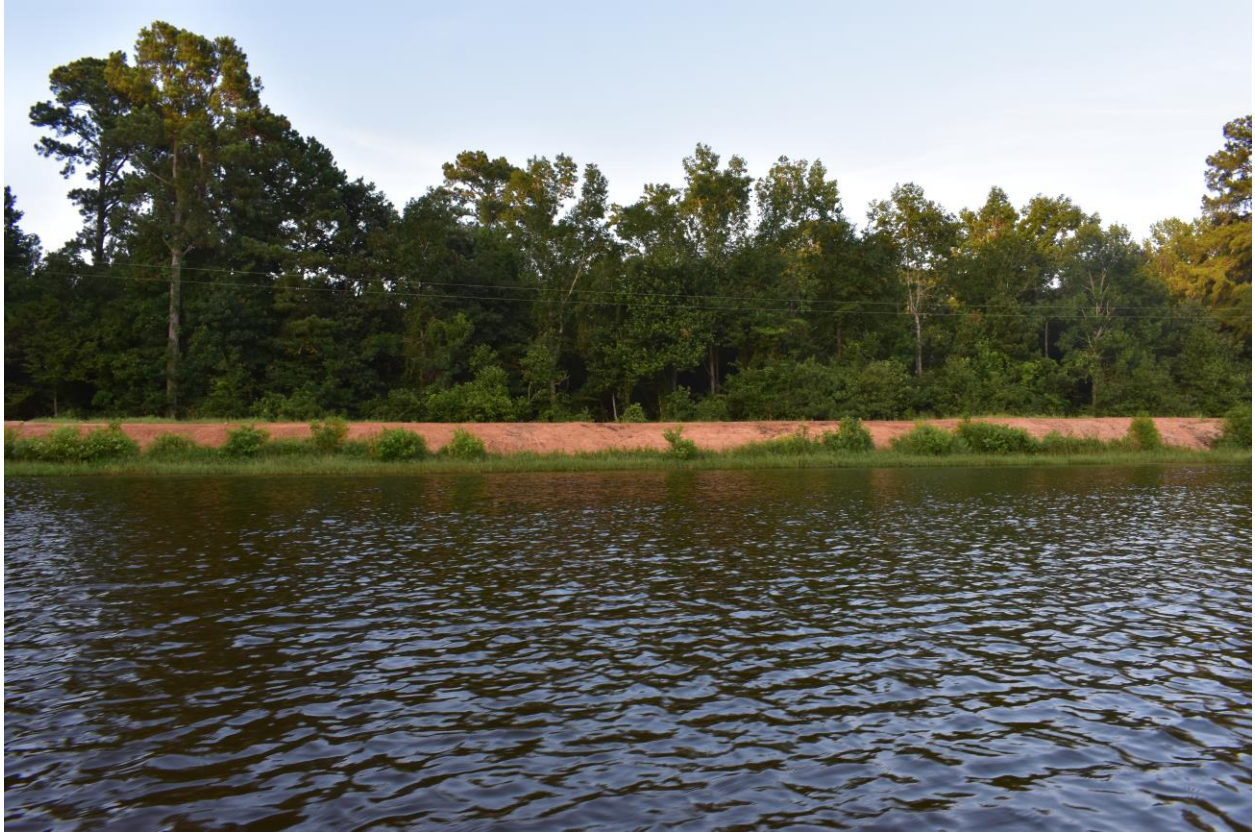
***Figure 17 - Front of the low flow pipe and hog damage. Before erosion control mat***
