June 24, 2024

The WCID board contracted the dam improvements proposed by the engineering firm back in 2019. The one area to build up is around the low flow pipe. The area around the low flow pipe has the largest slope and is the narrow part on the top of the dam. The back side of the dam around the low flow pipe is shown in figure 1 through 4. The front side of the dam around the low flow pipe is shown in figure 6. The WCID board received quotes from SRB in Colmesneil, TX and Kirkpatrick in Woodville, TX. The board evaluated both bids and the contract was awarded to SRB. SRB proposed building a rock wall above the low flow pipe and then adding dirt above it. The rock wall will hold the dirt better than just adding dirt and packing it down. SRB has also proposed building up the low area close to the spillway. SRB said that the low area was due to erosion and needed to be repaired. The board decided to go ahead with building up the low area as well. The low area is shown in figure 5. Just prior to getting the quotes for the work on the dam, pigs came out and damaged a large area on the front of the dam. The board decided to repair the hog damage shown in figure 4. The board also dec

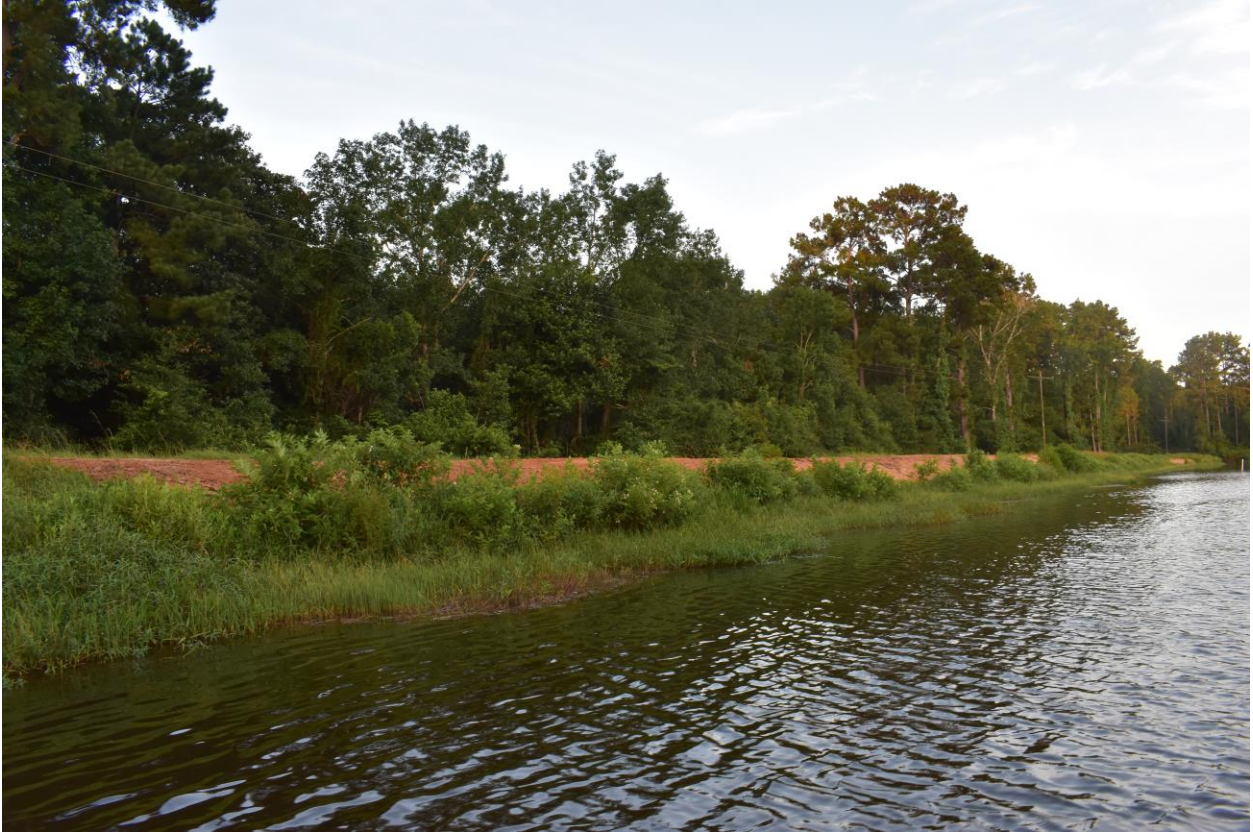
***Figure 18 - Front of the low flow pipe and hog damage. Before erosion control mat***
